Manhole Inspection Summary

Manhole # S25AA1009MH

Insp Date: **1/29/07 11:03 AM**

Location Address: **1300 36TH ST**

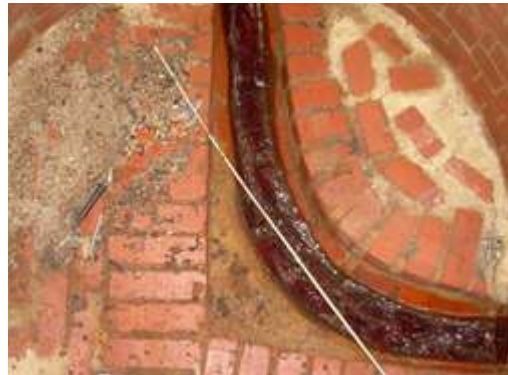
Top View

Bench debris.

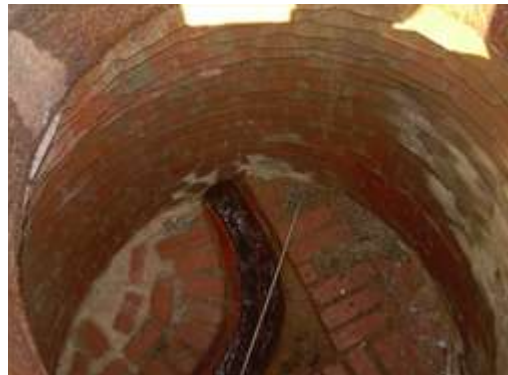
Defect

Frame leaks. Adjustment, Corbel and Barrel infiltration.

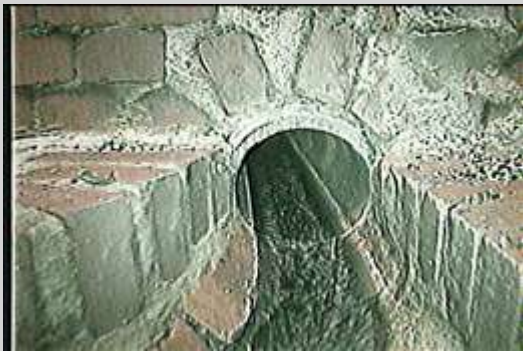
6 in. Circular Gravity Sewer Pipe In @ 3 O'Clock

Barrel deterioration and infiltration. Channel deterioration.

Deposits: ☐ None ☐ Mud ☐ Sludge ☐ Debris ☒ Grease

Infiltration: **Evidence**
